Metal-to-glass bonding properties of an acrylate adhesive (DELO GB368) and an ionoplast interlayer (SentryGlas) at 23, -20 and 60°C.

Christian Louter
Delft University of Technology, Faculty of Architecture
www.glass.bk.tudelft.nl, p.c.louter@tudelft.nl

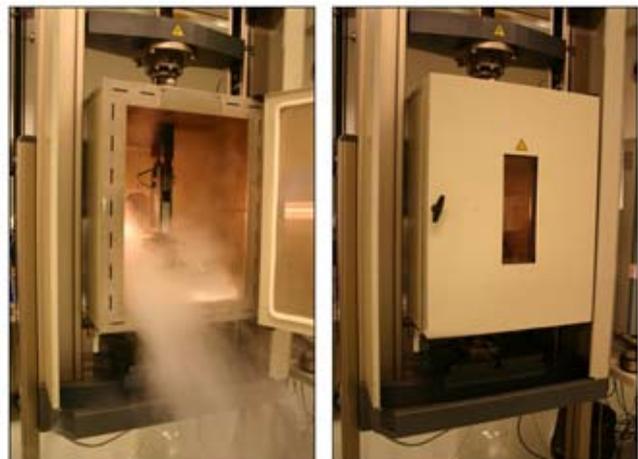
Figure 5:
A climatic chamber has been put around the test setup to either cool to -20°C (left) or heat to 60°C (right).

For the pull-out tests at -20 and 60°C an insulated climatic chamber has been put around the test setup, see figure 5. This climatic chamber has been either cooled with vaporized liquid nitrogen or heated with an electric heating element. A fan at the back side of the climatic chamber generated an air flow throughout the climatic chamber which ensured an even temperature level throughout the climatic chamber.

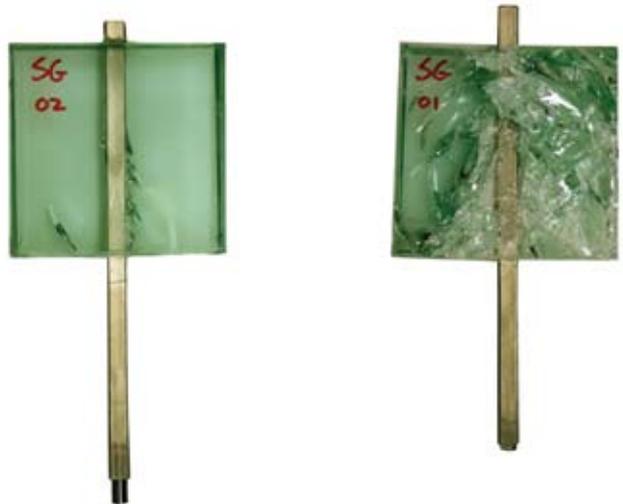
Figure 8:
Specimen SG(23)#02 shows only minor cracks in the inner layer, whereas specimen SG(23)#01 shows severe cracking. Both specimens have been tested at room temperature.

Also the SG-specimens showed linear elastic response at the beginning of the loading procedure without showing any slip of the metal insertion, until at a load of about 26 to 28 kN the response became more ductile. At this loading level the applied force approached the tensile strength of the metal insertion and the metal insertion started to yield and contract. For specimens SG(23)#02 and #03 the applied force showed only limited increase until at a displacement of 22 mm the metal insertion started to slip, see figure 6. At this displacement level the load suddenly dropped to a residual friction load of 5 kN, which was needed to pull the metal insertion further out of the glass laminate. Visual inspections of the specimens showed debonding of the metal insertion, stretching of the SG-interlayer and some minor cracks in the inner glass spacers, see figure 8 (left). The response of specimen SG#01 was different since it showed severe cracking at a load 29 kN, see figures 6 and 8 (right). This cracking did not severely affect the load carrying capacity of the specimens, and after a small drop the load further increased, see figure 6. Subsequent cracking of both glass spacers, however, caused slip of the metal insertion and a drop in load.

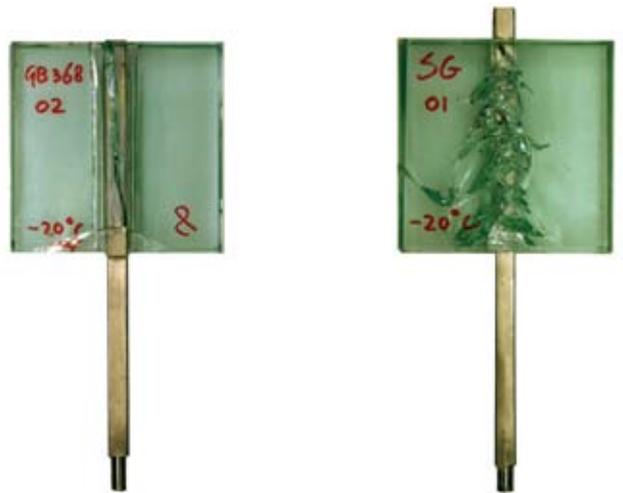
Figure 9:
Specimen ACR(-20)#02 shows a linear crack (left) and specimen SG(-20)#01 shows more severe cracking.

at room temperature (from average 21.3 to 11.8 kN). Specimen ACR(-20)#02 showed a similar linear crack at one bond line as was observed for an acrylate specimen tested at room temperature, see figure 9 (left), whereas the other specimens showed no cracking at all.

The specimens showed some glass cracking along the bond line of the metal insertion. This cracking was more severe at specimen SG(-20)#01, which showed cracking of the outer glass layer, see figure 9 (left) than at the other two SG-specimens tested at -20°C, which showed some cracking of the inner glass spacers. On average the SG-specimens showed the same strength as the specimens tested at room temperature; namely 30.1 kN compared to 30.2 kN at room temperature. Visual inspection of the specimens showed debonding of the interlayer at the metal insertion and
